CERCLA SITE REASSESSMENT REPORT

H. M. Arnold/Chevron Chemical Co.
GAD980556831
137 East Fambrough St.
Monroe, Walton Co., Georgia 30655

September 11, 2002

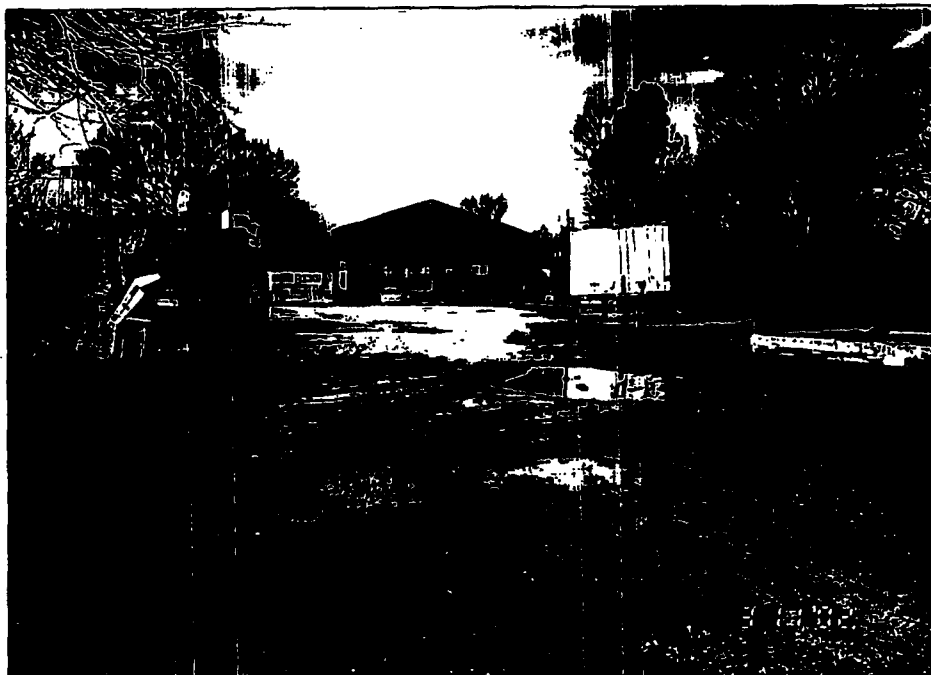
Site Name: H. M. Arnold/Chevron Chemical	Photo 1 of 4	City, County: Monroe, Walton County
Date: 3/11/2002 Dir. Facing: N	Time: 1440	Photographer: Billy Hendricks Haz. Waste Mgmt. Branch
Explanation: View of site from road entrance

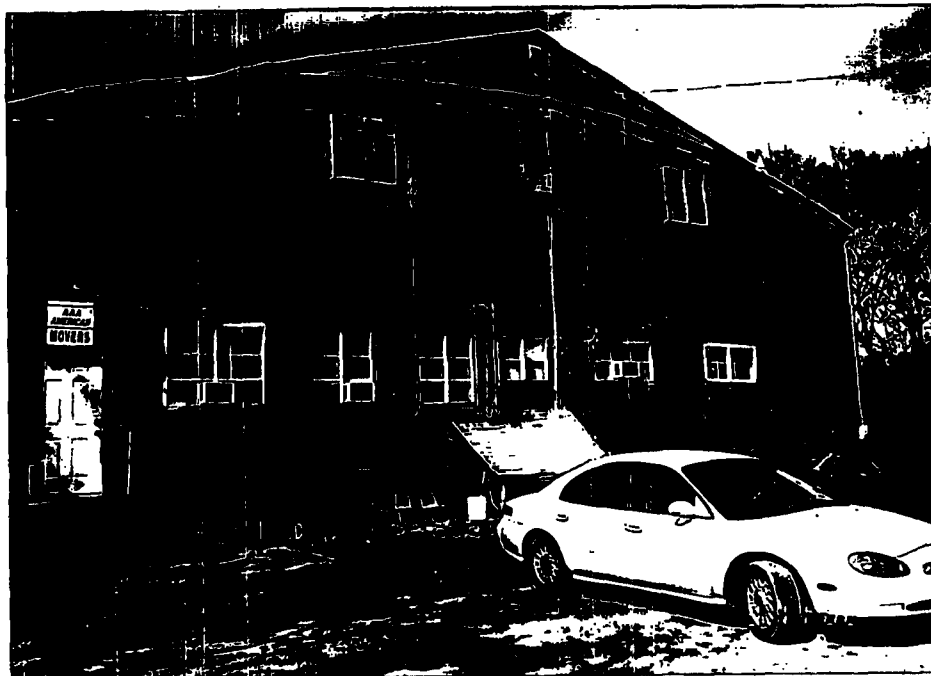
Site Name: H. M. Arnold/Chevron Chemical	Photo 2 of 4	City, County: Monroe, Walton County
Date: 3/11/2002 Dir. Facing: NNE	Time: 1500	Photographer: Billy Hendricks Haz. Waste Mgmt. Branch
Explanation: Front of building; note "AAA American Movers" sign over office door, left.

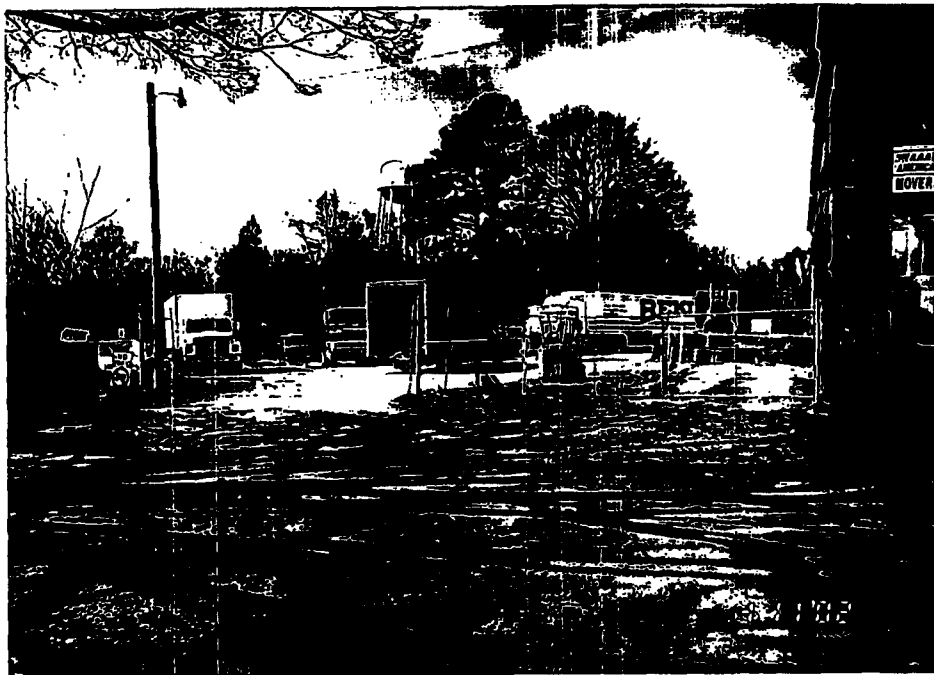
Site Name: H. M. Arnold/Chevron Chemical	Photo 3 of 4	City, County: Monroe, Walton County
Date: 3/11/2002	Dir. Facing: N	Time: 1500
Photographer: Billy Hendricks Haz. Waste Mgmt. Branch		
Explanation: Western side of property, currently used for truck parking and vault staging. This area was excavated, adjacent to the building only, during the 1984 removal action.

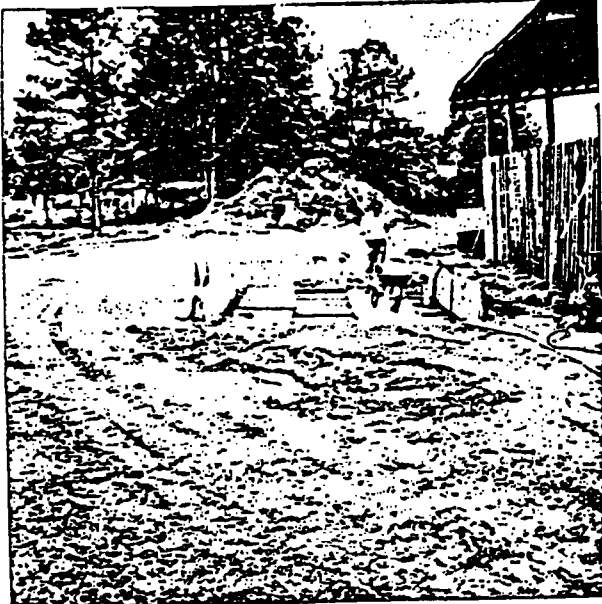
County Name WALTON
 Picture No 1 of 2
 Site Name H.M. Arnold Company
 Date 5-1-84 Weather Partly Cloud
 Direction Facing NW
 Photographer Jeff Williams
 Program RAU (EHWP)
 Explanation: Photograph of
the decontamination
station that was set
up to clean trucks
 Other: transporting the
waste material off
site Note excavated
pile of soil in the
background

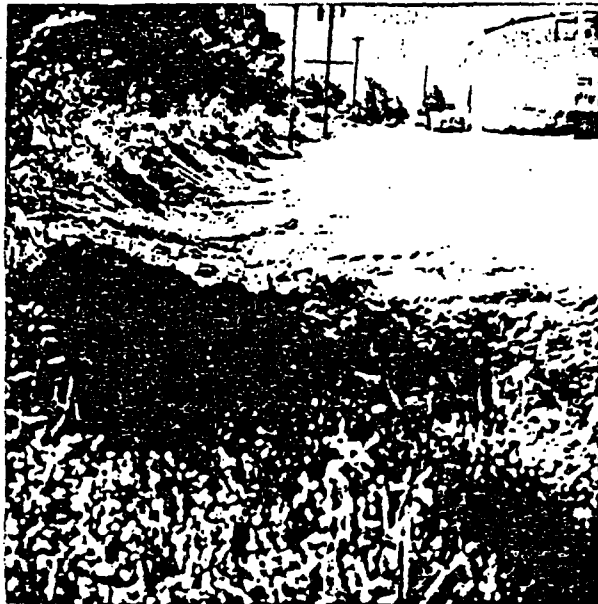
County Name WALTON
 Picture No 3 of 4
 Site Name H.M. Arnold Company
 Date 5-10-84 Weather Clear
 Direction Facing South
 Photographer JEFF Williams
 Program RAI (THWMP)
 Explanation: Photograph of
the drainage ditch
that lies parallel to
the railroad tracks.
 Other: Excavation of
the soils surrounding
the culvert at the
site was completed
to insure against
future contamination.

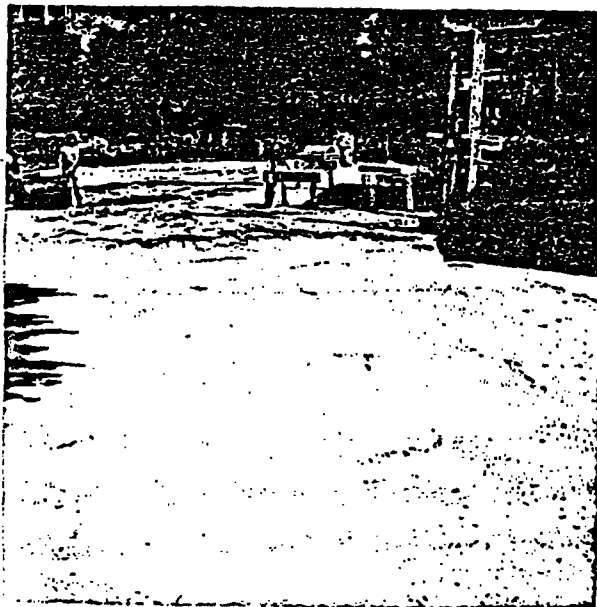
County Name WALTON
 Picture No 4 of 4
 Site Name H.M. Arnold Company
 Date 5-10-84 Weather Clear
 Direction Facing North West
 Photographer JEFF Williams
 Program RAI (THWMP)
 Explanation: Photograph of
the "bulking area" area
to the west of the
warehouse building.
 Other: Silos where the
decontamination station
was set up. Warehouse
is in upper right of
photograph.

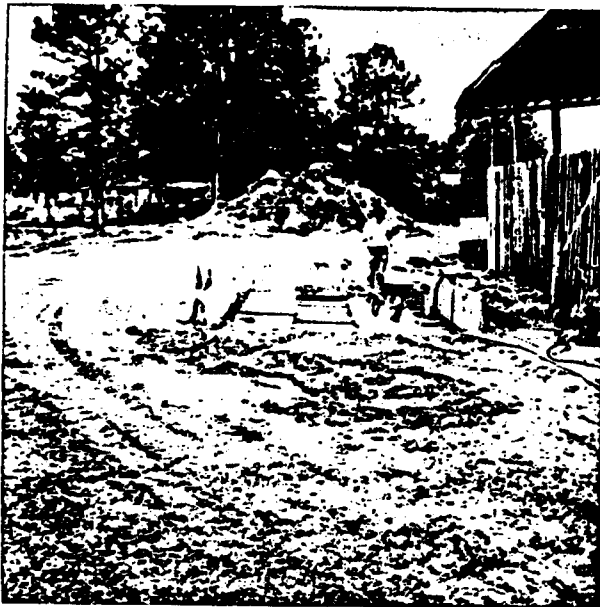
County Name WALTON
 Picture No 1 of 2
 Site Name H.M. Arnold Company
 Date 5-1-84 Weather Partly Cloudy
 Direction Facing NW
 Photographer Jeff Williams
 Program RAU (IHWMP)
 Explanation: Photograph of
the decontamination
station that was set
up to clean trucks
 Other: transporting the
waste material off
site Note excavated
pile of soil in the
background.
